GROUP **Body**	MODEL **Sedona VQ**
	NUMBER **040 [Revised]**	DATE **February 2009**

TECHNICAL SERVICE BULLETIN

POWER SLIDING DOOR (PSD) CONTROL MODULE REPLACEMENT

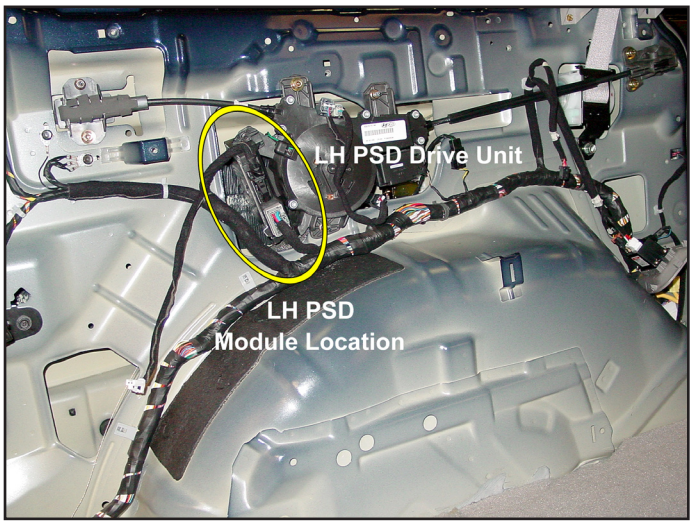
LH (driver's side) PSD drive unit and control module is shown here.

There are two PSD modules, one for each PSD. They are located on each of the two PSD drive units, behind the inner rear trim panel, above the rear inner wheel wells.

Referring to Case A or Case B, replace the PSD control modules or module as necessary with part number 95450 4D102. Follow the service procedure provided in KGIS under Body Electrical, Power Sliding Door System, Power Sliding Door Module.

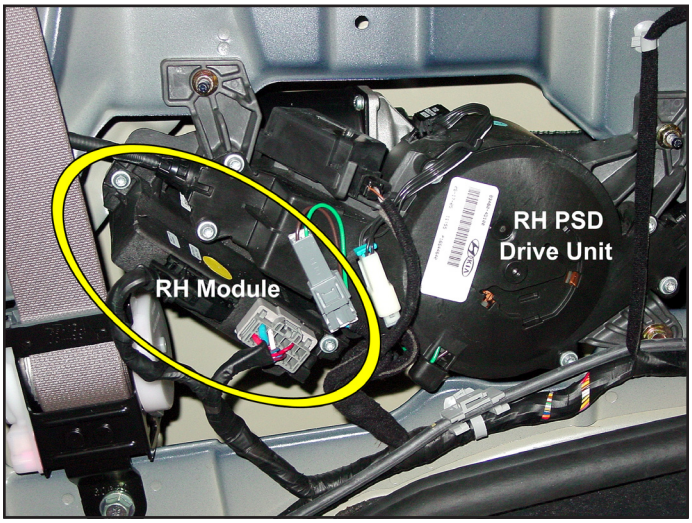
A close-up view of the RH (passenger's side) PSD drive unit and control module is shown here. The module is attached to the PSD drive unit in a similar, but slightly different area.

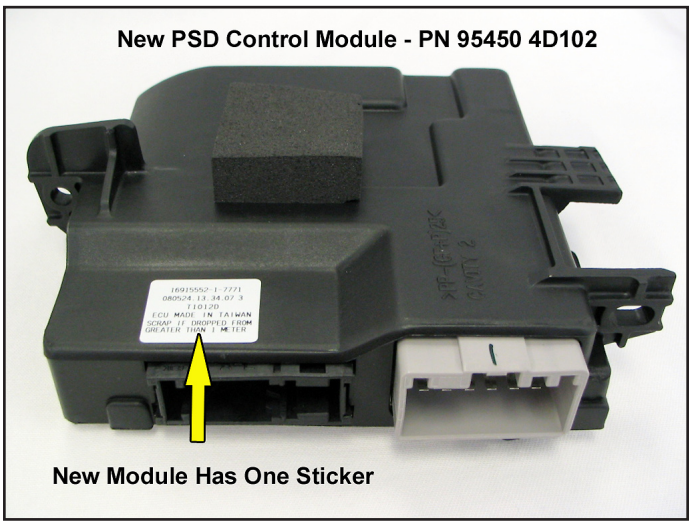
Both new control modules share a common part number (95450 4D102) and are fully interchangeable.

Original module has two small white colored stickers applied to the case.

New module only has one larger sticker applied as shown here.
