SUBJECT: <b>PCM REPROGRAMMING FOR DTC P1540 AND DTC P1541</b>		No: <b>TSB-06-13-002</b>	
		DATE: <b>April, 2006</b>	
		MODEL: <b>See below</b>	
CIRCULATE TO:	<input type="checkbox"/> GENERAL MANAGER	<input type="checkbox"/> PARTS MANAGER	<input checked="" type="checkbox"/> TECHNICIAN
<input checked="" type="checkbox"/> SERVICE ADVISOR	<input checked="" type="checkbox"/> SERVICE MANAGER	<input checked="" type="checkbox"/> WARRANTY PROCESSOR	<input type="checkbox"/> SALES MANAGER

**PURPOSE**

2006 Galant 2.4L MIVEC A/T models with California emissions produced before 2/23/06 (Vehicles produced on or after this date are corrected for this condition during production.)

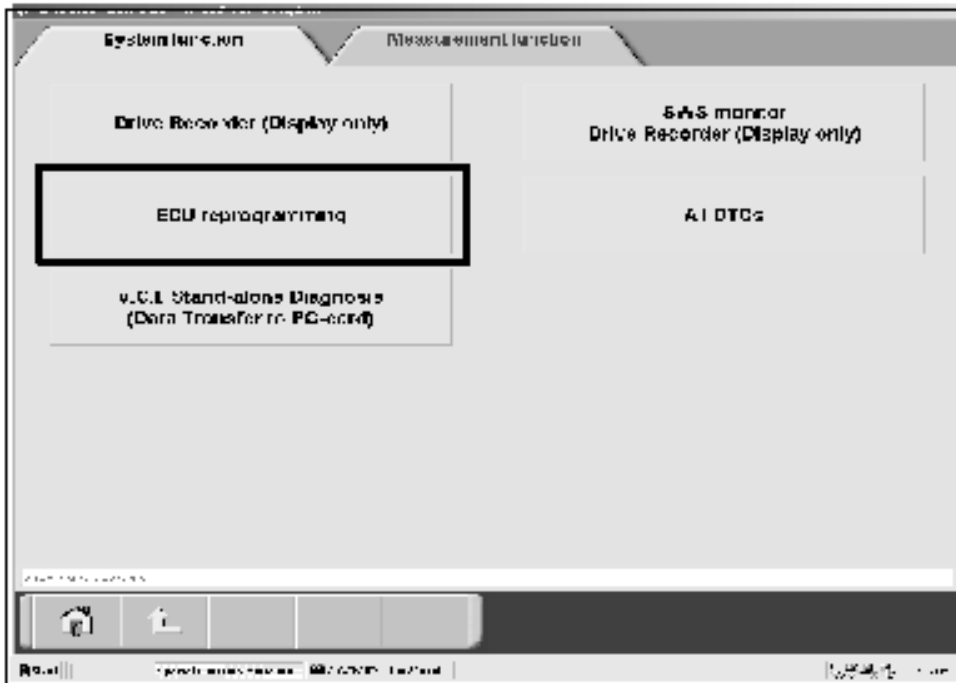
9. Select "Automatic Reprogramming (CAN)."

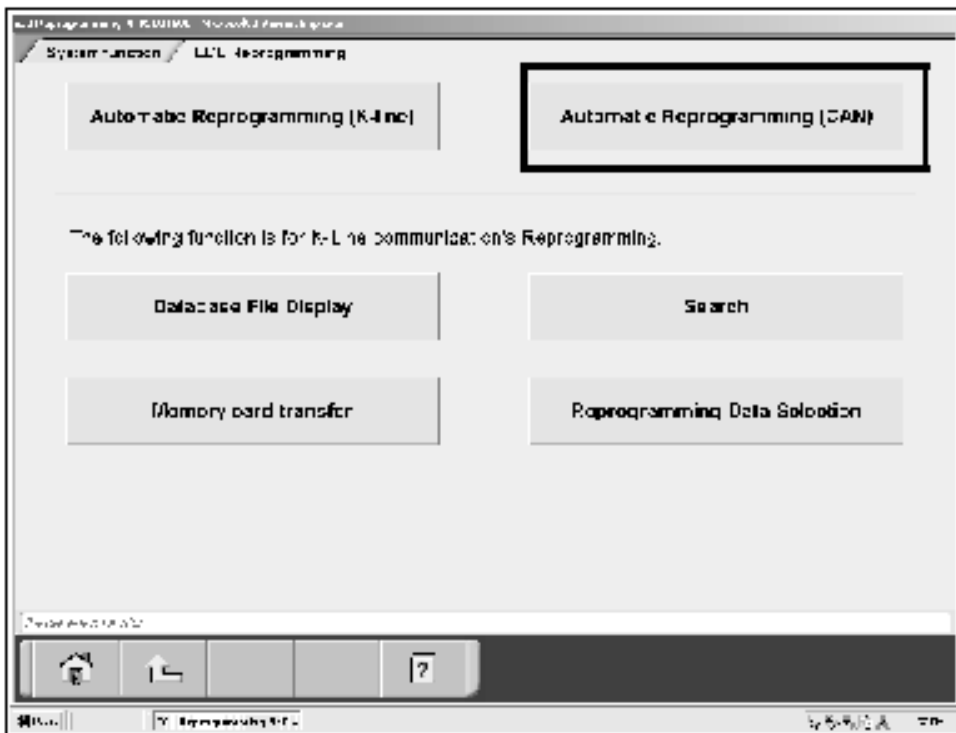
10. Select Engine and Transmission, then click on the check mark.

A message will advise you that the system will "Automatic Search the data." Click on the check mark to continue.

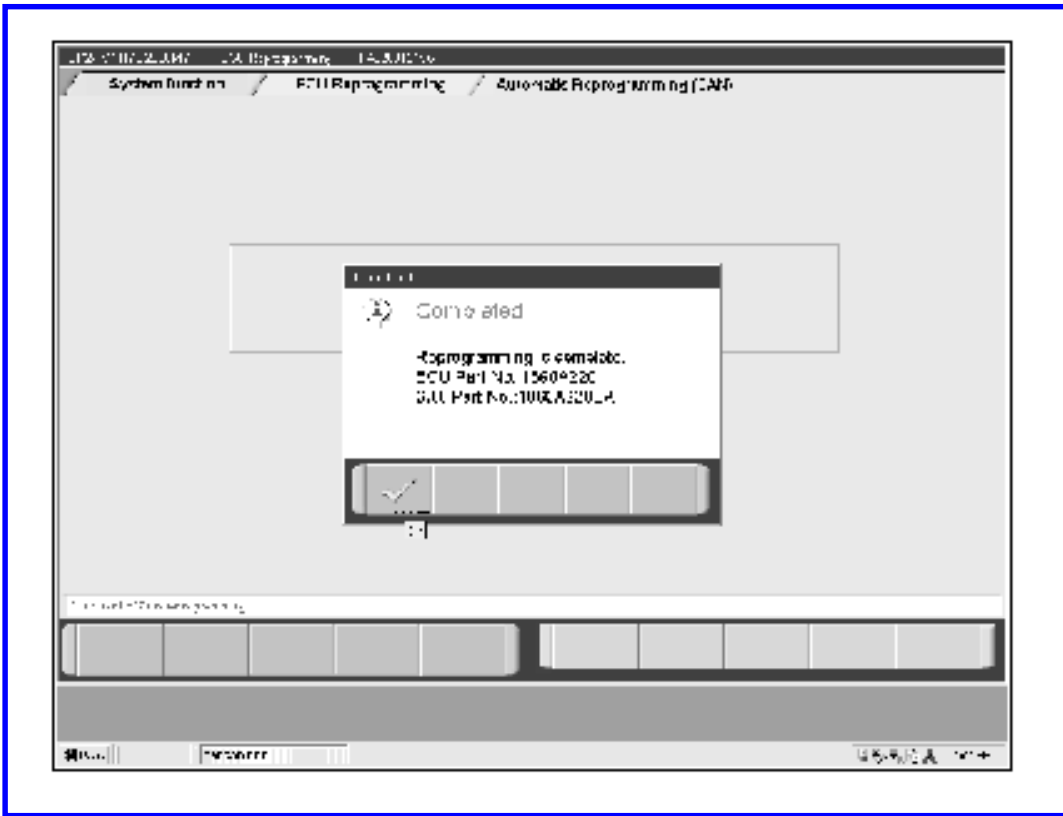
13. After reprogramming, the new ECU part number and software part number will display. Verify that they are the same as those listed below. Note this information.

DISPLAY ON MUT-III AFTER REPROGRAMMING		
MODEL	ECU P/N	MUT-III REFLASH DATABASE	ECU P/N	Software P/N (ROM ID)	VENDOR #
2006 Galant 2.4L MIVEC Calif. emissions	1860A316	1862A552	1860A316	1860A316CA	E6T41683H20
