## REMOVAL

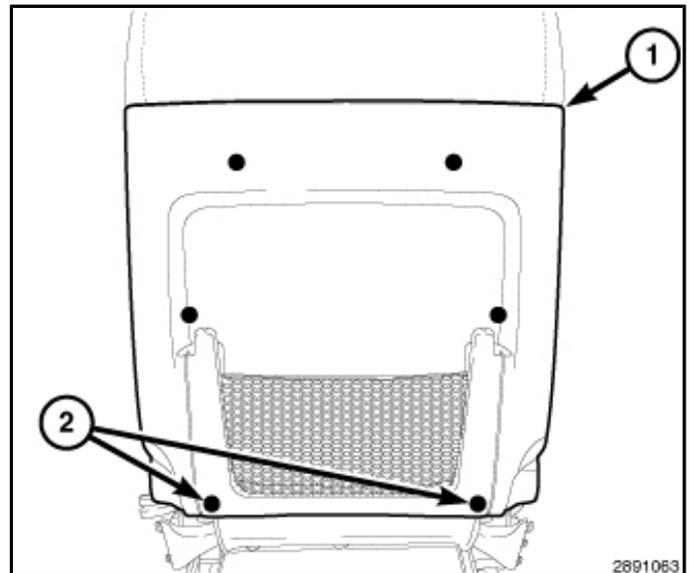
1. Before proceeding with the following repair procedure, review all warnings and cautions. (Refer to 23 - Body/Seats - Warning)
2. Position the seat being serviced all the way forward.
3. Disconnect and isolate the negative battery cable.
4. Release the lower back panel retaining clips (4).
5. Lift the bottom of the back panel (2) up at the bottom and release the panel hooks (3) and upper hooks (1) and remove the back panel (2).

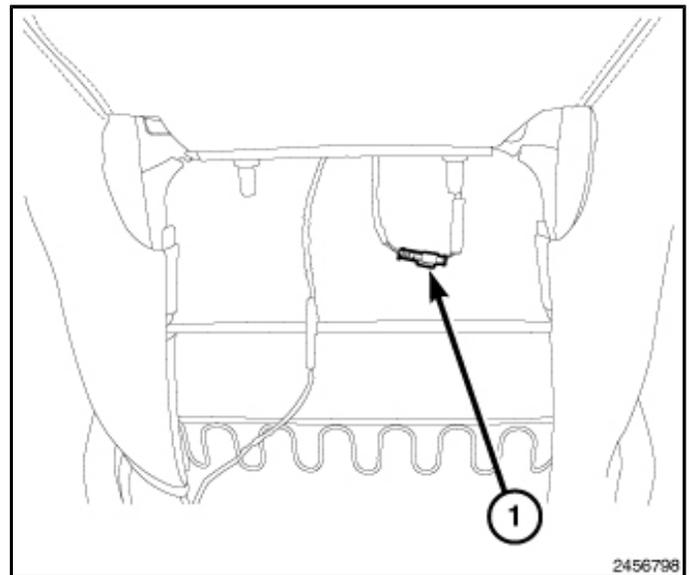
6. Disconnect the electrical connector (1).

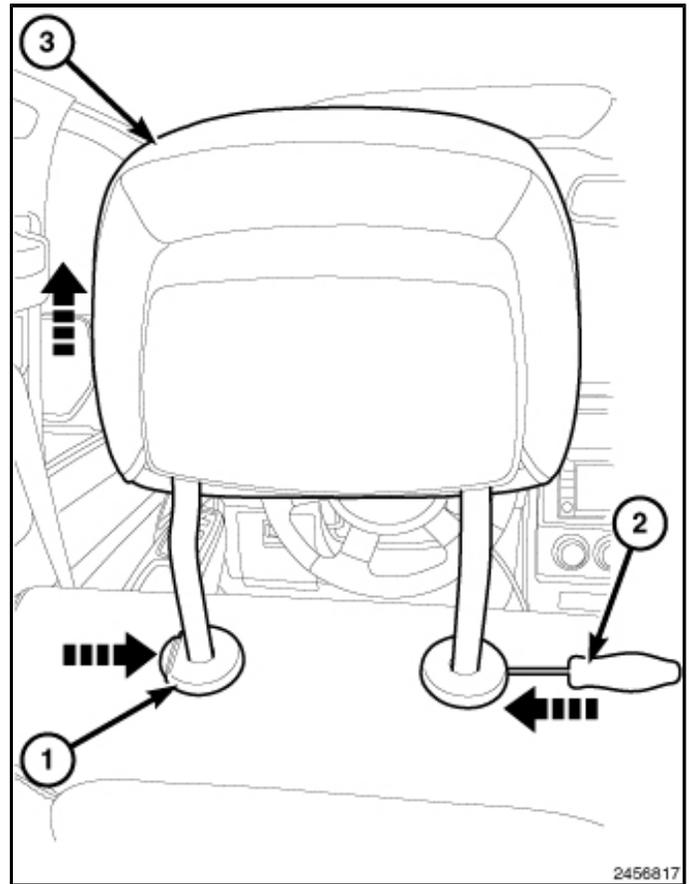
2456817

7. Recline the seat to gain enough room to remove the AHR (3).
8. Press the release button (1) on the left side headrest master sleeve.
9. Using a thin wire type tool (2), press the hidden release button on the right side headrest slave sleeve.

10. Slowly lift the AHR (3) up while pressing the buttons simultaneously.
11. Watch the connector as it reaches the bottom of the tube and guide the connector through.
12. Remove the AHR (3) fully.

**CAUTION:** Special care should be taken not to damage to the AHR connector.
